# **Wrestles with Anui**

**The first six months of work**

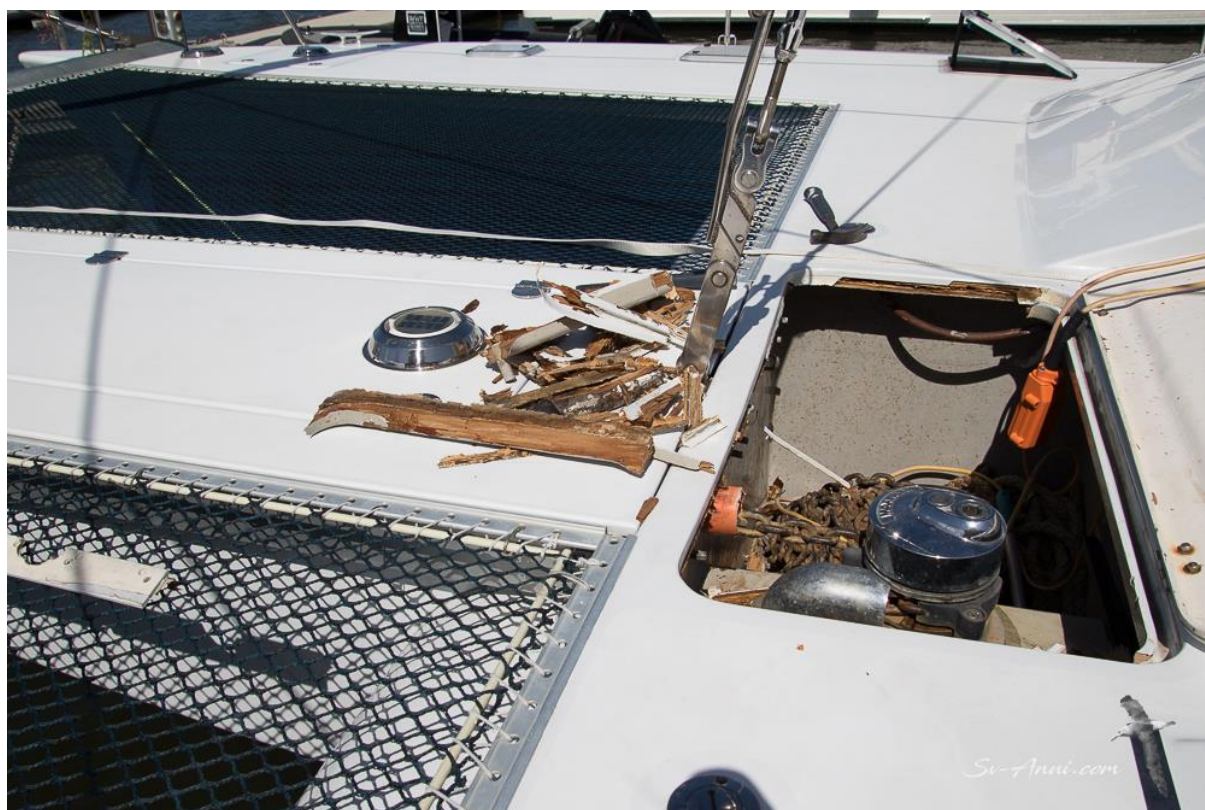
The rot was a surprise. The boat is foam sandwich construction. But the edges of the anchor hatch were made in wood to simplify the process of getting a lip in the hatch and rounded corners. Unfortunately water got in and the lip of the locker rotted. It was ugly as we had to chase the rot till we got back to the foam core, a lot further than we expected. Ryan Thacker from 143 Boat Building took care of this and we were impressed with his thoroughness but practicality. He is now our shipwright.

We have lived through dealing with rot on our previous boats and knew the drill: get back to healthy wood, seal it, put new and healthy timber in and glass it, then repaint. But we had not expected this on a foam core and fiberglass construction!

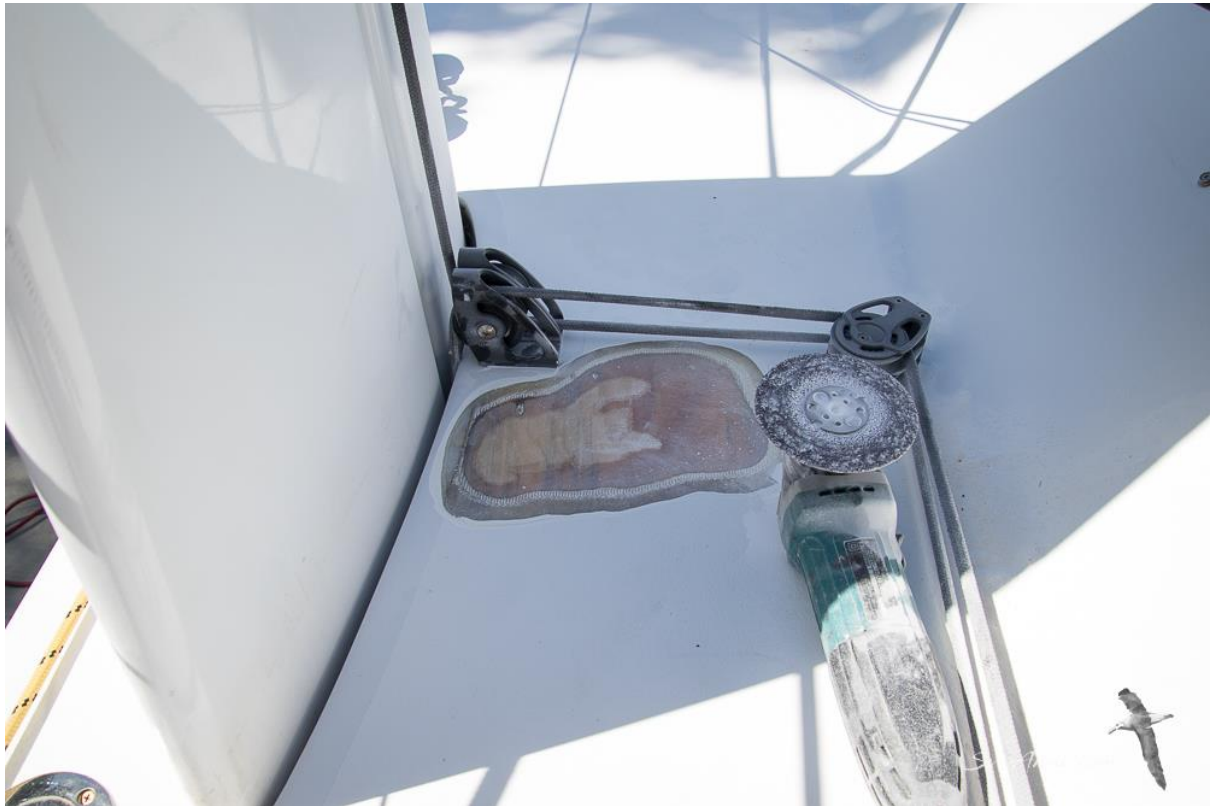
As for the area of delamination next to one of the dagger boards, it involved grinding the spot down, bogging it, re-glassing and repainting. It is not hard, but it takes time. Ryan also took care of this. The cost of this work had been negotiated as part of the purchase price. So for us, the main expense was marina fees. The work got done in a wet berth at Boat Works.

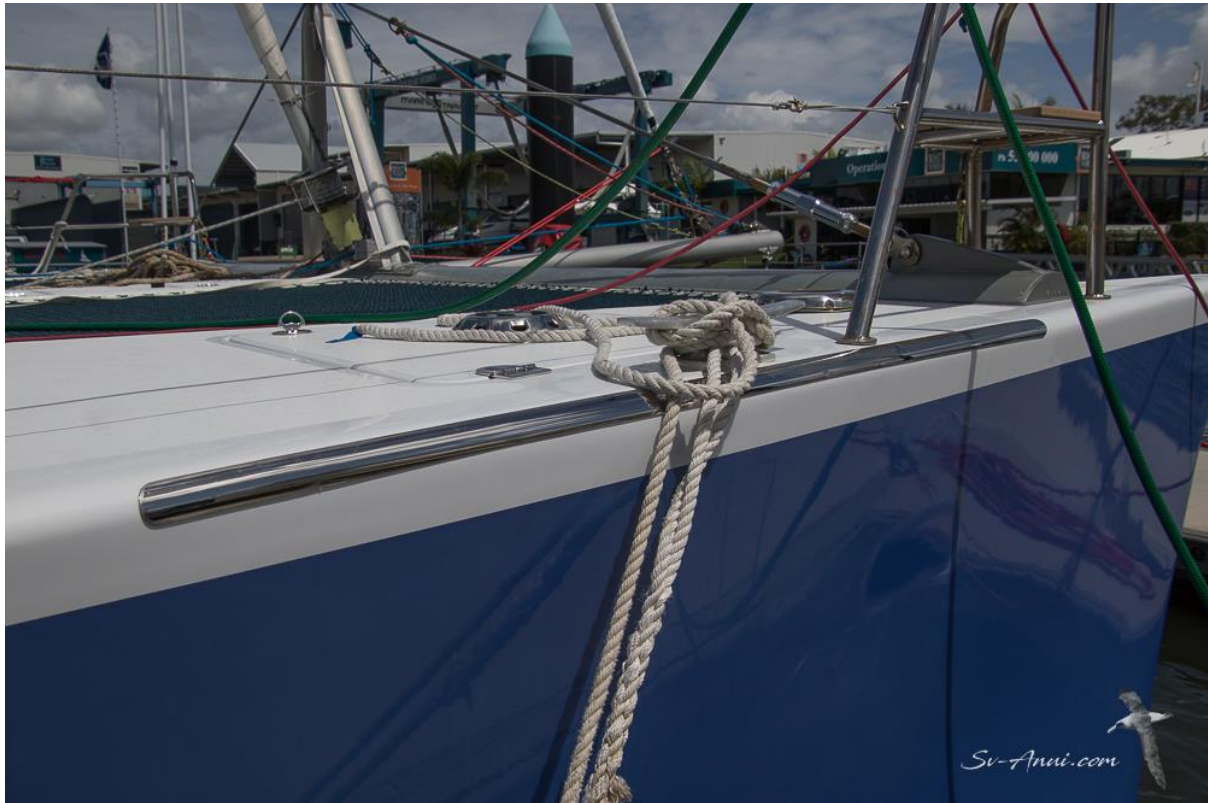
On Anui, the edge of the hulls was not protected against mooring ropes rubbing. So we had Choice Stainless Steel at Boat Works shape some stainless steel strips and affix them to the edge of the hulls. We now have three of these along each hull wherever the cleats are.

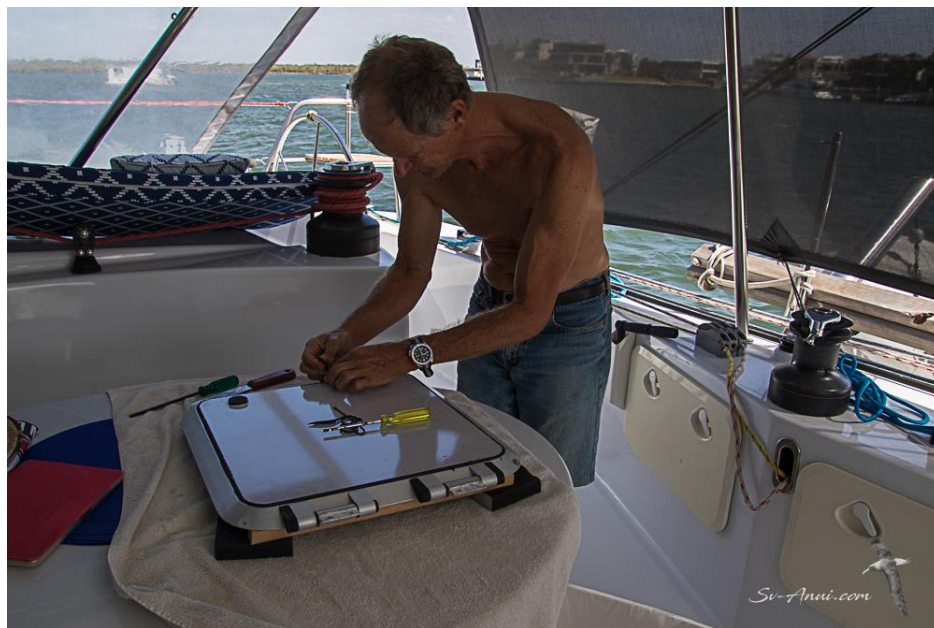
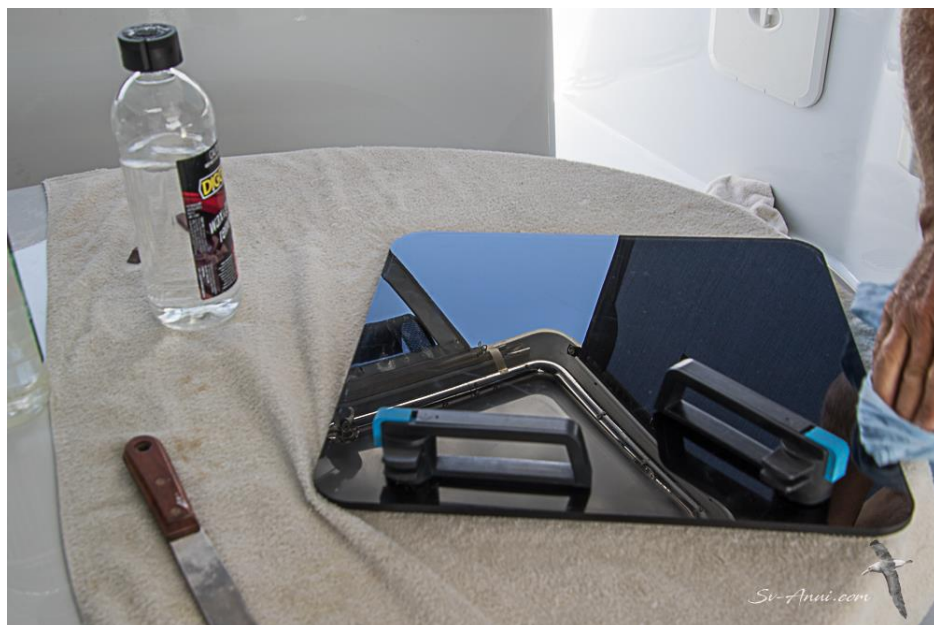
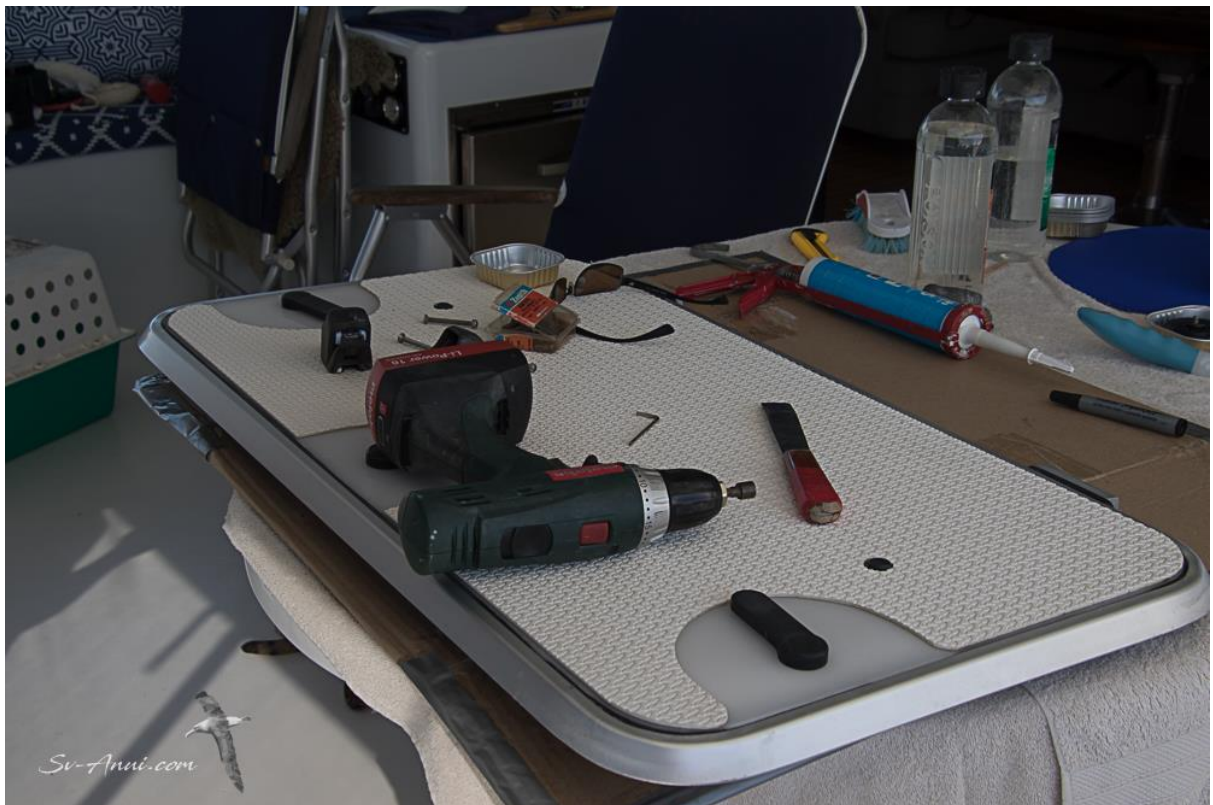
During the deluges, Anui did a great impersonation of a sieve! It was raining inside...buckets, pots and pans were strewn around everywhere to catch the copious drips. There are 16 hatches around the cabin, the bedrooms, the bathrooms, the galley and every one was leaking, some more than others! Some of the hatches leaked from the dried up seals between the glass and the frame, others leaked between the frame and the deck, and a few leaked from both spots! Over several weeks, they all got resealed.

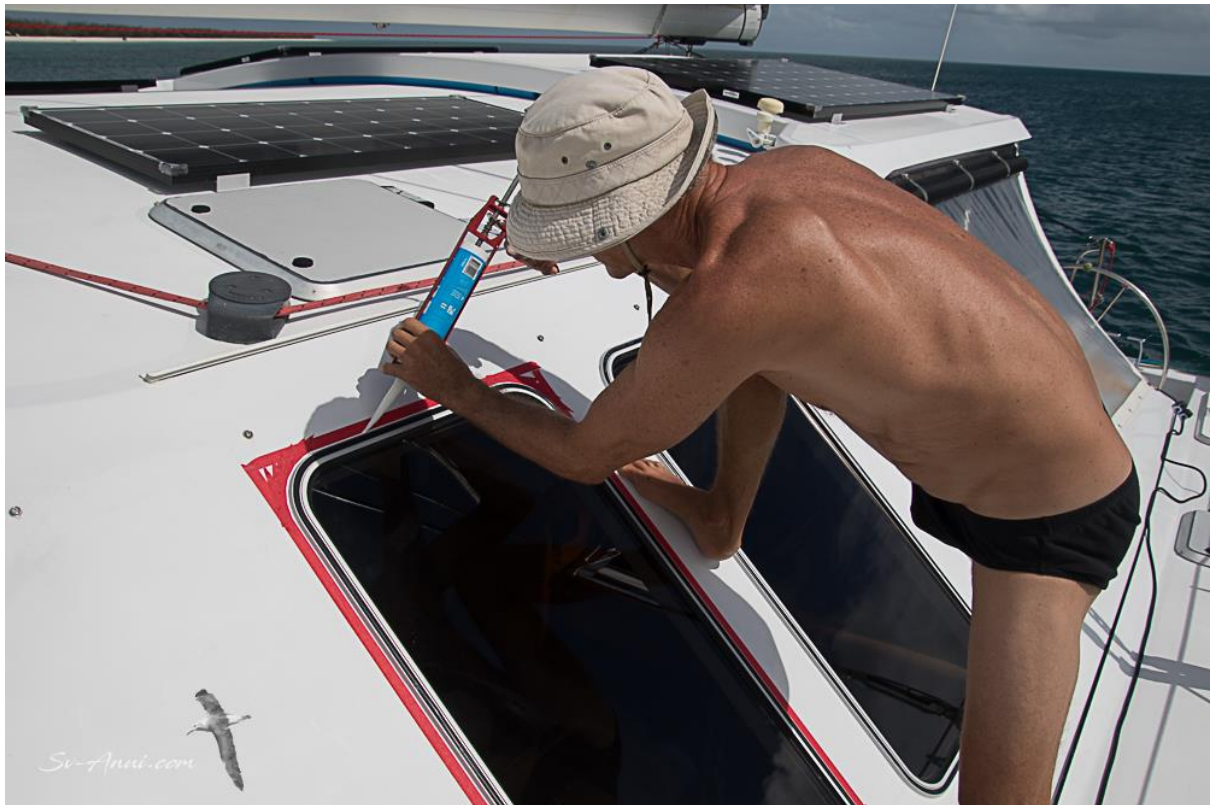
Not particularly keen on taking out the big windows, Wade cleaned up the old sealant around the surrounds of the frames with the hope that it would be sufficient. It was in 5 out of 6 of those windows. For one recalcitrant one, the glass had to come out also as we still had dribbles at the next bout of rain.

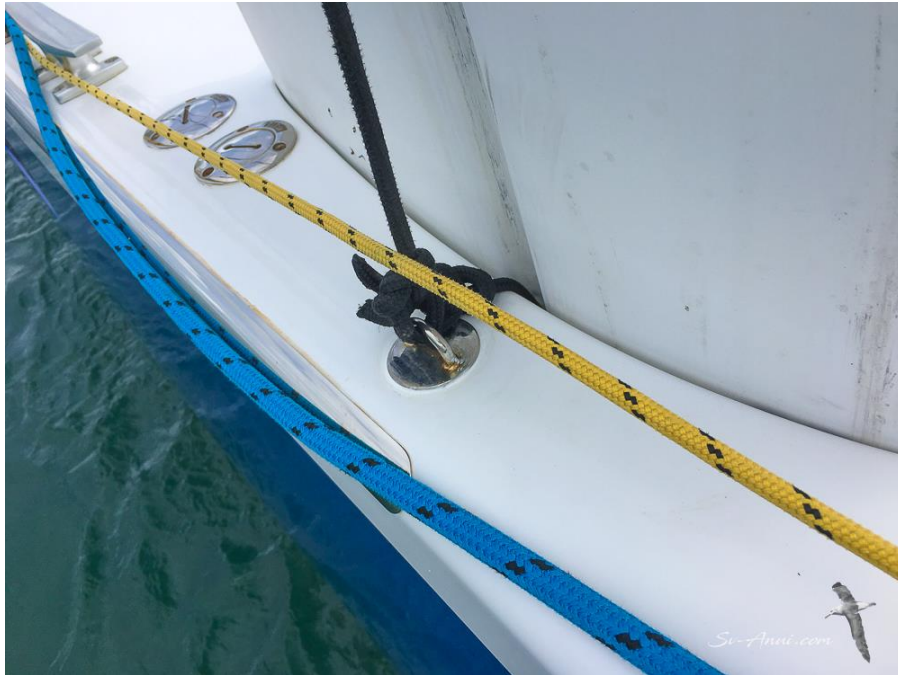
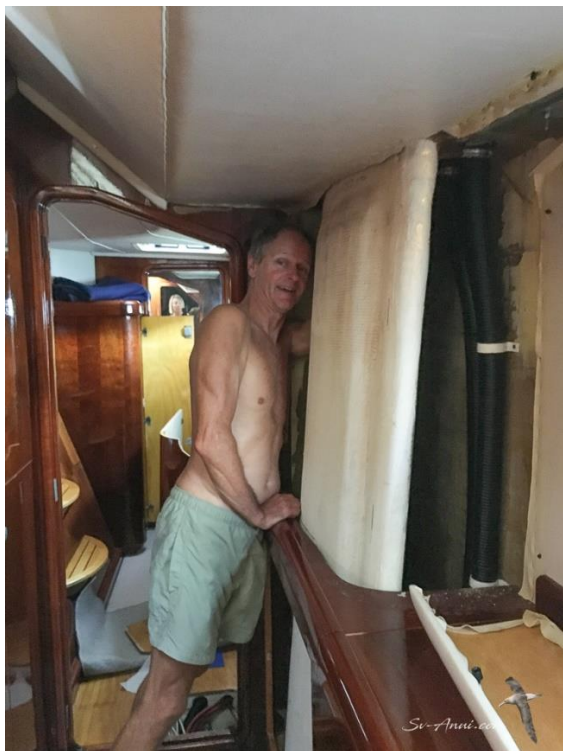
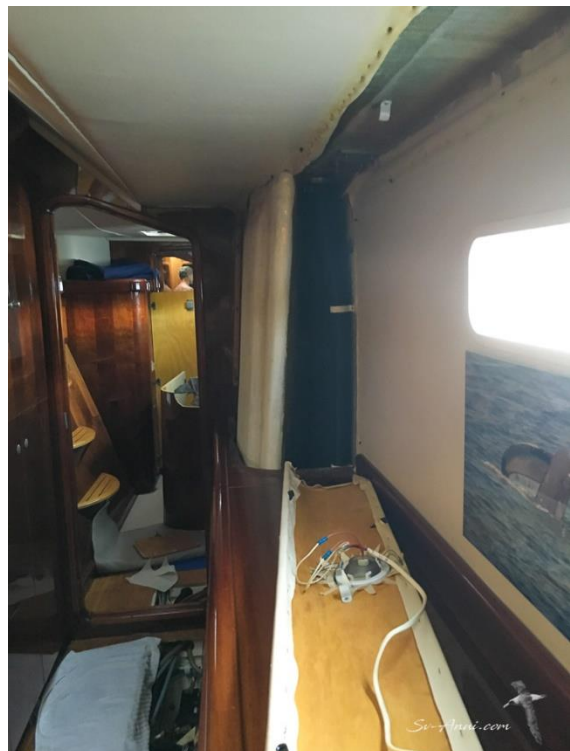
One was easy to get to, being a jib sheet pulley just on the coach roof. The other one was harder; Wade found fresh water was collecting in the sump. Upon investigation he found it was the u bolt next to the dagger board which allows it to be dropped or raised. This required us to deconstruct the cedar paneling inside to gain access to the dagger board and reach behind it to be able to reset the bolt!

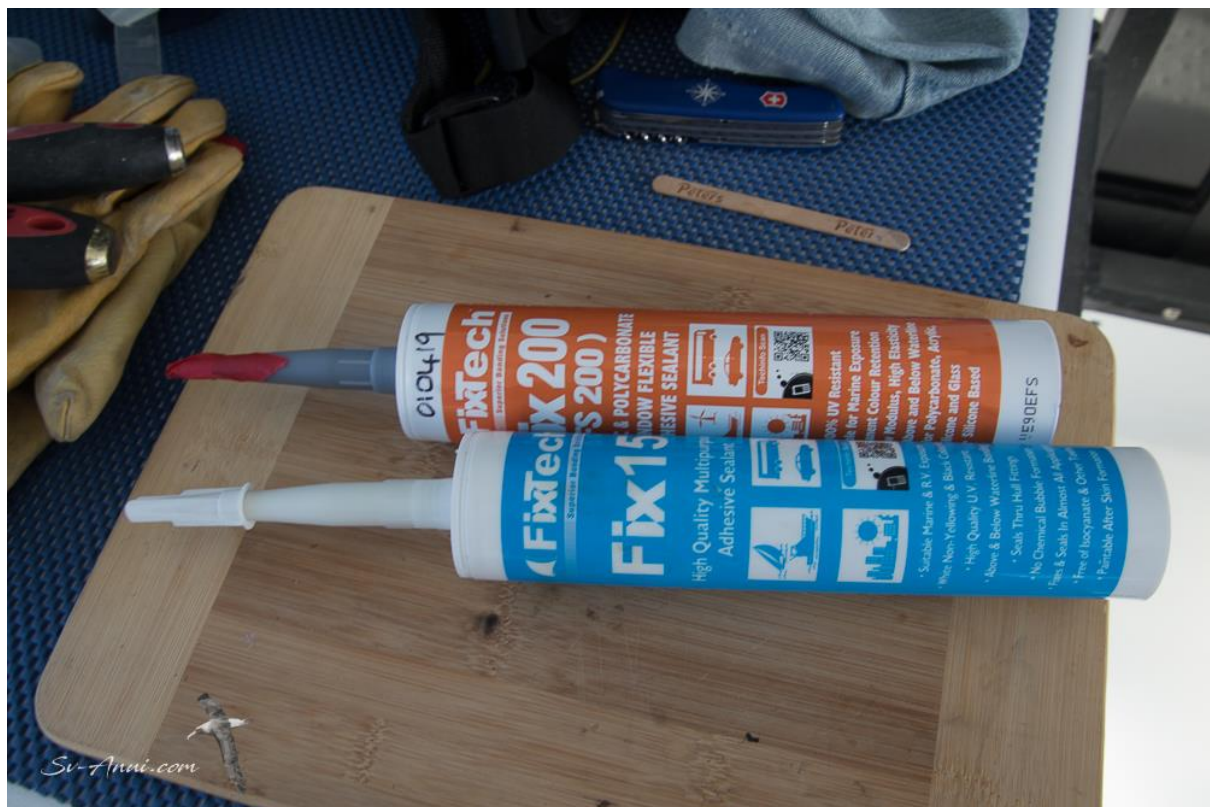
All this resealing is not a terribly difficult job to do, but it is time consuming and what takes the longest is the clean-up of the old goop so you have a totally clean surface to put new adhesive sealant on. If you don't do this carefully, the product does not adhere properly, and you are back to square one with leaks. We went through an incredibly large number of sealant tubes! We reckon we should have shares in the Fix Tech Company! We used two of their products: Fix Tech SF200 in black used to seal the glass into the frame, and the Fix Tech 15 in white which seals all fittings to the deck.

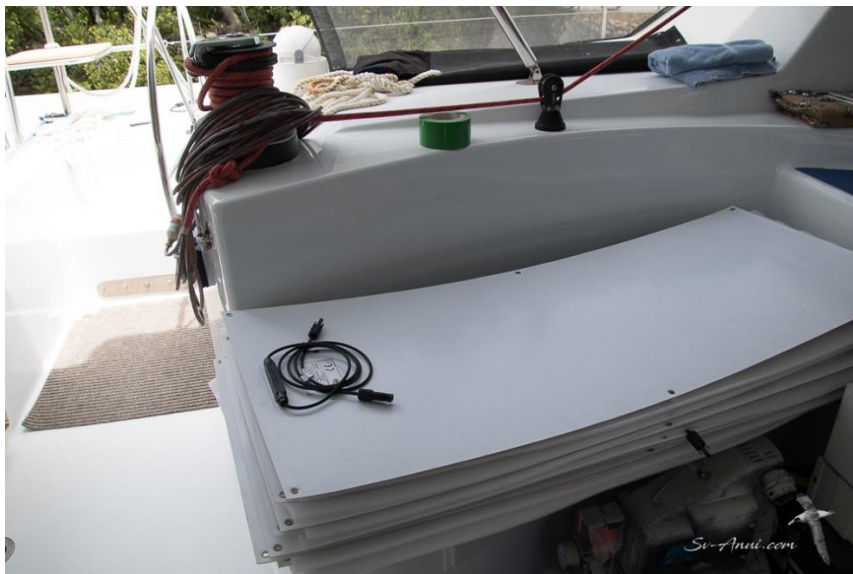
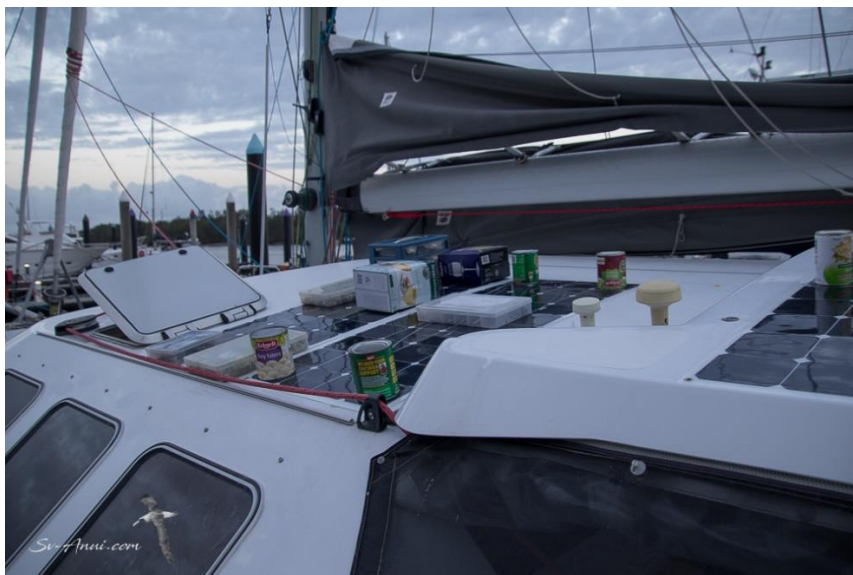
So we proceeded to remove the existing panels, clean up the roof, adjust the connection points and stick the new panels on the roof, then called an electrician to take care of the connection. Being on the cabin and cockpit roof, when you sail, some of the panels can end up being in shadow, so they are connected in pairs and in a particular way, something beyond our area of expertise!

We had to weigh the panels down with what we could so the adhesive goop would do its job! Tins, dive weights, casks of wine were requisitioned!

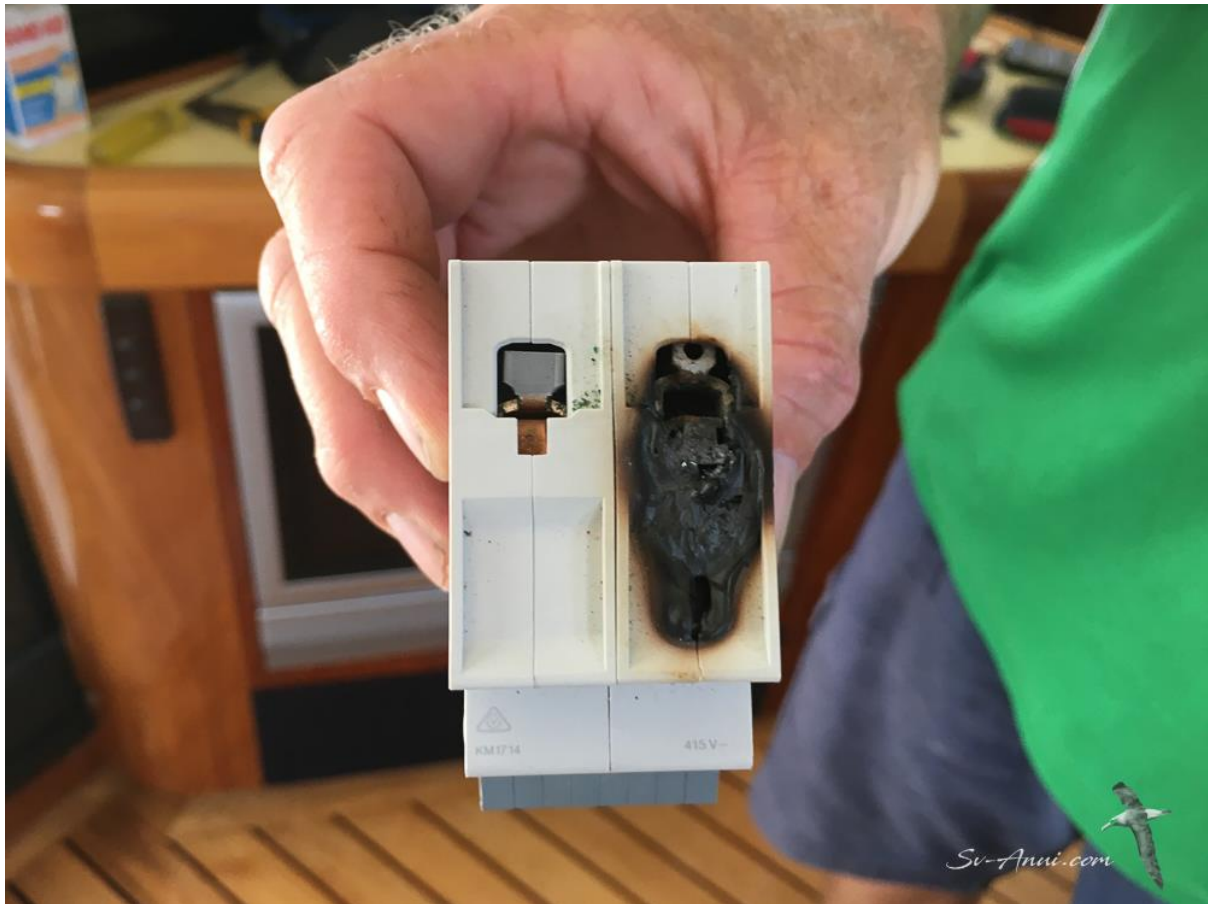
First, there was the small matter of wires not properly connected to the power board and shorting, which could easily have started a fire. We certainly were not impressed with the previous electrician's work.

This circuit breaker was replaced and wires properly reconnected.

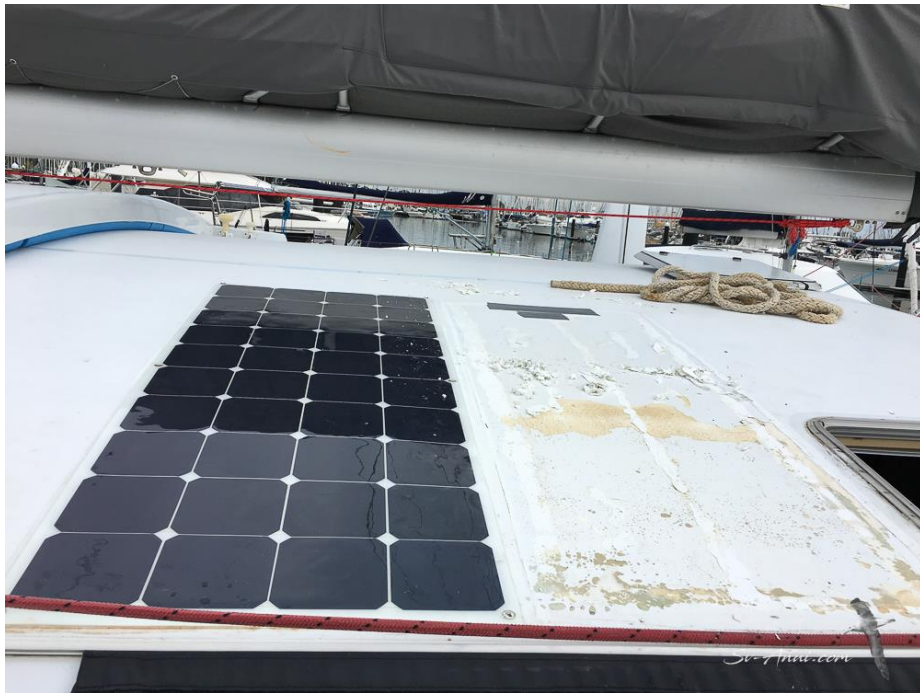
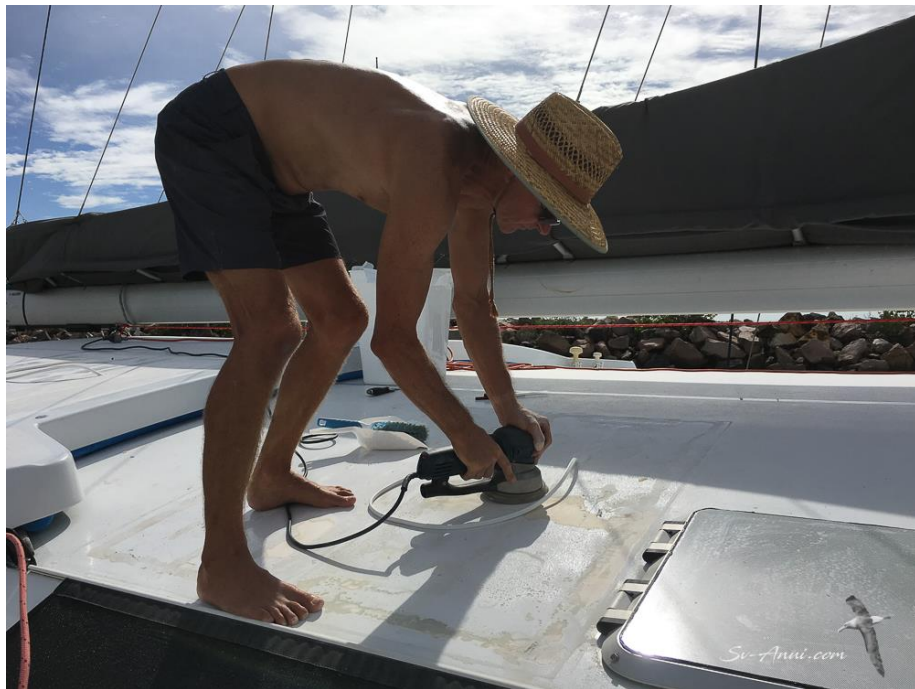
Removal of the original panels and clean up of the roof!

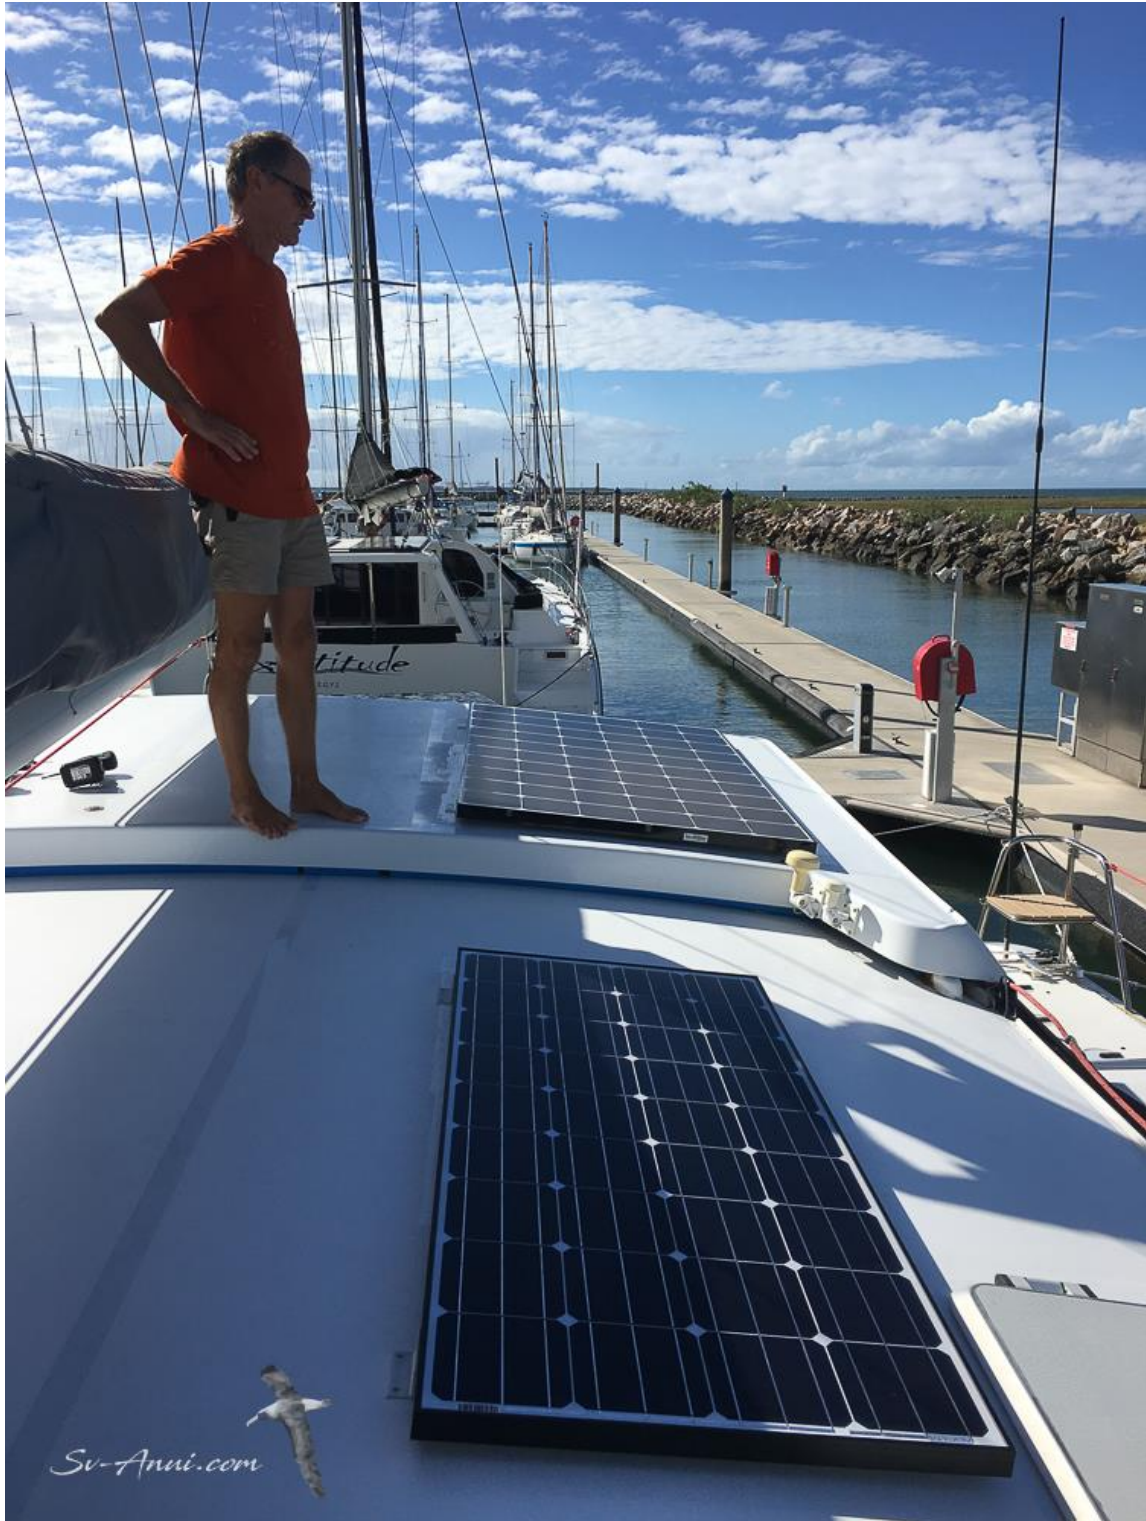
Port side rigid panels in place

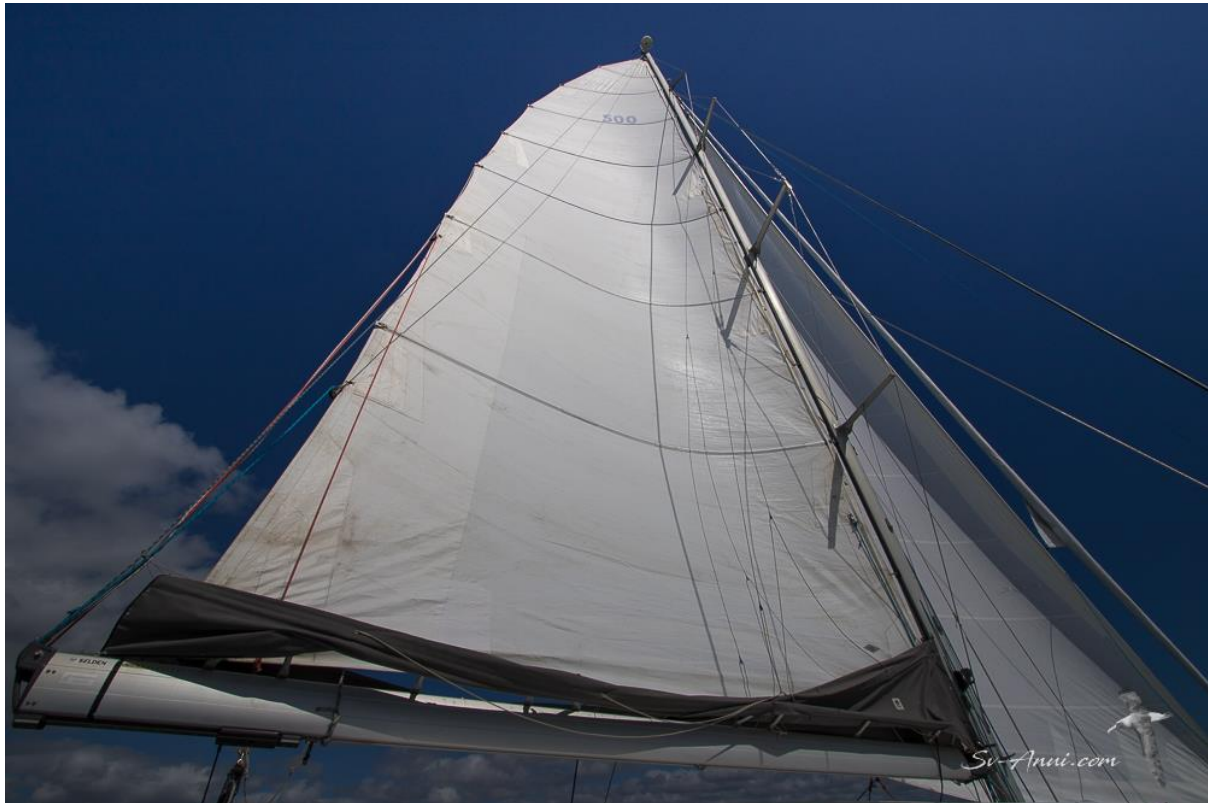
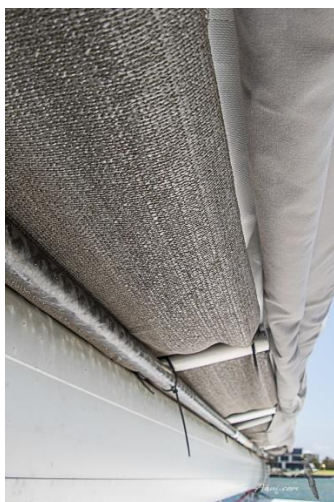
It only took three weeks. At the very first opportunity to sail in Moreton Bay in brisk conditions requiring a reef, we managed to rip off the first reefing point! We also noticed how damaged the bottom panel of the mainsail was: yellowed from sun damage, on big patch already stuck on, the cloth next to it threatening to tear at the slightest provocation.

The sun damage was particularly noticeable on the bottom panel of the sail. One of the things we discovered is that on larger boats, the main when down is often flaked out in a cradle rather than straight into a boom bag. This was the case on Anui. The problem with this kind of cradle is that it is open to reflected light from the deck which very quickly damages the bottom panel of the sail. The rest of the sail is protected inside the boom bag, which is attached to the outside of the cradle.

So we fitted a length of shade cloth at the bottom of the cradle to protect the sail from any further damage while allowing rainwater to fall through.

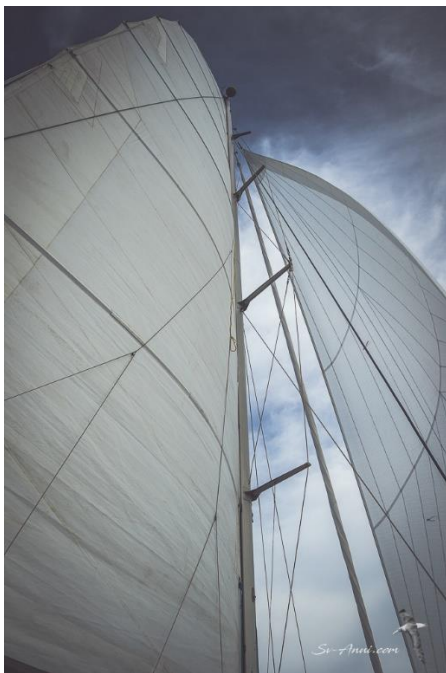
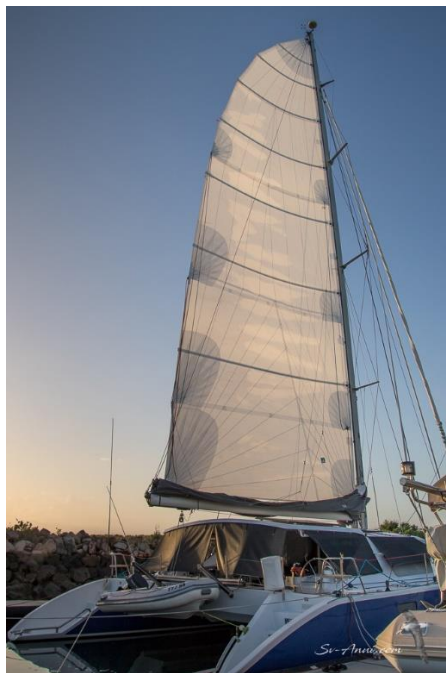
Mike also altered the top of the sail so the headboard is easier to fit, and altered the boom bag so the whole sail and headboard would fit inside it. The sun is a killer. No point spending a small fortune if you don't protect the sail when not in use. Here is the before picture on the left - Dacron straight cut, and the after picture on the right – radial cut Hydranet! You can see the difference in the number of radial panels on the right, compared with the broad bands on the cross cut construction on the left.

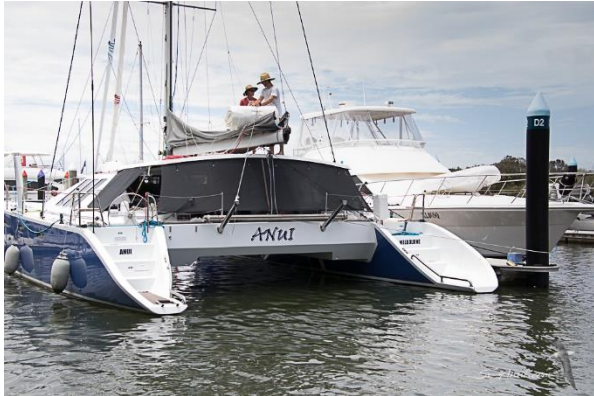
Shady cockpit – when you are at anchor you want a shady, cooler cockpit and protection from sun and heat on all your hatches. So investing in shade cloth that is easy to roll down and back up around the cockpit is a necessity. Anui already had shade cloth in good condition around the cockpit, and although black in colour, it has the added advantage of providing a degree of privacy.

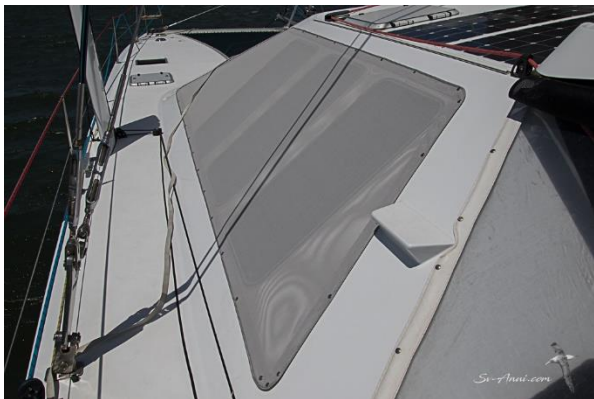
The big side windows were covered with the same black shade cloth and could be clipped on or off with press studs. The cloth blocks 70% of the sun and heat but still lets you see out. However we found that in full sun, the temperature of the windows was hotter than everywhere else on the top sides and over time cracked the paintwork. We have had the paint repaired and have replaced the black cloth with very light grey material. We got ours made by Marine Canvas & Trimming at the Boat Works.

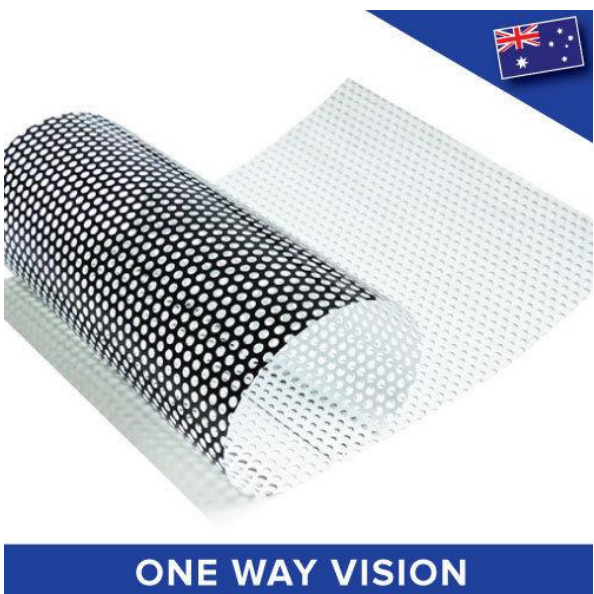
For the smaller hatches, we installed some perforated One Way Vision vinyl film to reduce the sun and heat penetration into the cabin. This can be purchased in rolls and is relatively easy to cut to size and stick on the hatches. It really cuts down the heat. One side of the vinyl is white, the side you look through from the inside of the cabin is black.

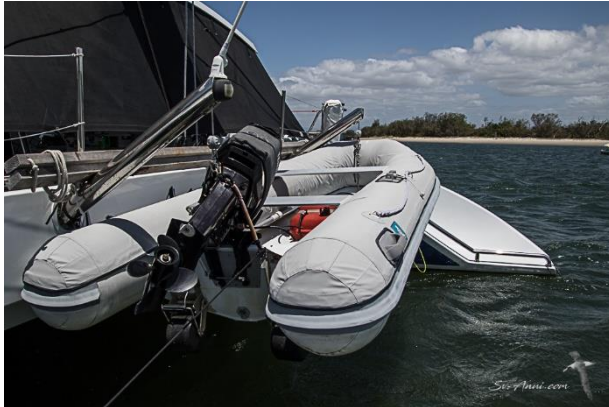
Dinghy Chaps – if your dinghy is an inflatable one, get some chaps made to protect the tubes. Without them over time the PVC or Hypalon will perish. This had happened on Peasy, Take It Easy's tender. With age, the tubes go sticky and become impossible to clean. Getting chaps is a lot cheaper than buying a new dinghy! And pick a light colour if you want to be able to sit on the edge without burning your bottom. We got ours made by Gold Coast Sailmakers.

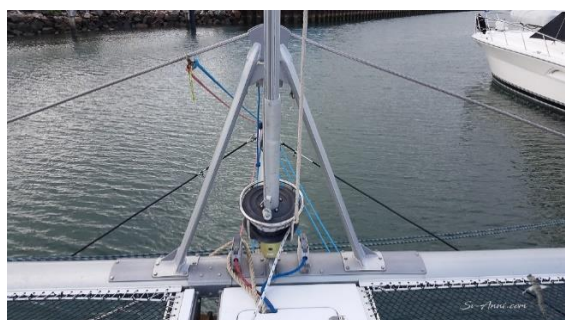
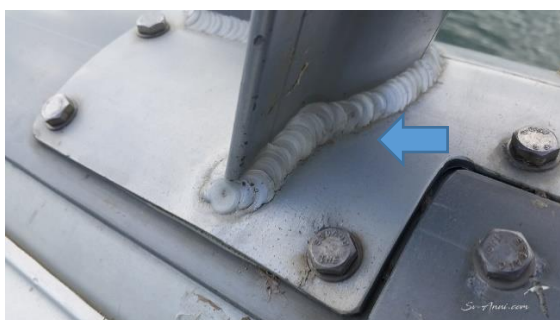
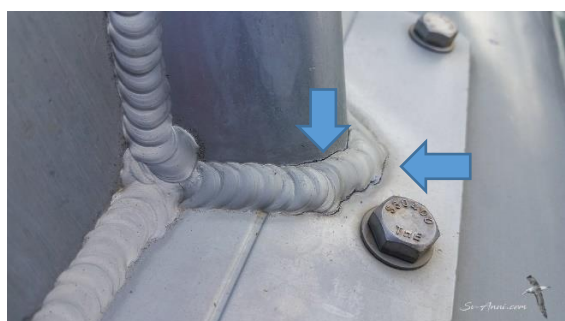
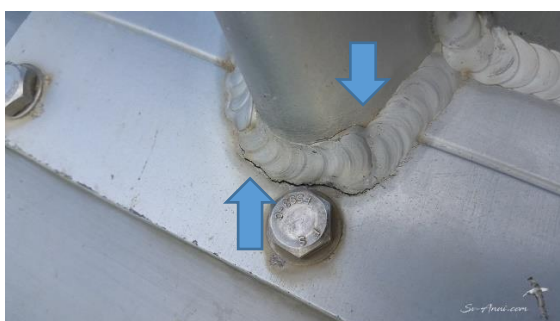
One nasty thing that was discovered post survey was a crack at the base of the A-frame along the welding line. This is hard to see, but once you know it is there, you can definitely spot it!

Why did the cracks develop in the A-frame? Possibly wear and tear... Anui is nearly 20 years old, aluminium wears over time. It may also have not been built strong enough in the first place. The rigger's indication was that the cracks were not new and had been there for a while. We were rather fortunate to have discovered this while in the marina. If the A-frame had failed offshore, it could have had disastrous consequences. We had not noticed the cracks when we checked the boat, and neither did the marine surveyor. And no, we did not put a claim against his insurance, even though we had paid extra for him to check the rigging at survey time. We figured we would get the thing fixed and move on!

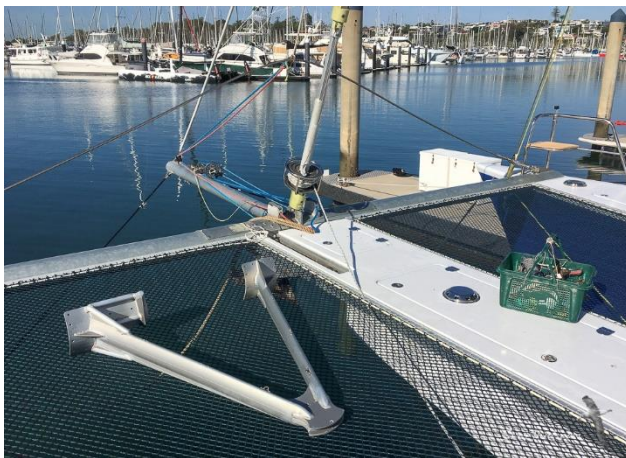
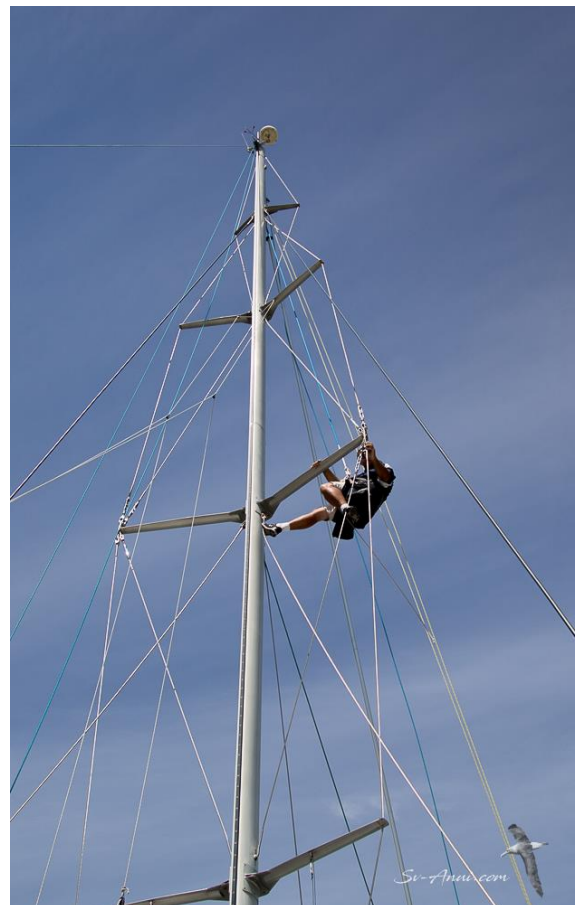
A frame ready to be re-installed, and Scott checking the rigging!

The frame was then anodized. We were out of action for five weeks during the construction and anodizing time! Scott Keogh also climbed up the mast to check our rigging and found a couple of cracks in the lower tangs where the lower back shrouds attach to the mast. He declared the rigging safe to sail with, but we will get the tangs replaced at the end of this season when the boat comes out of the water!

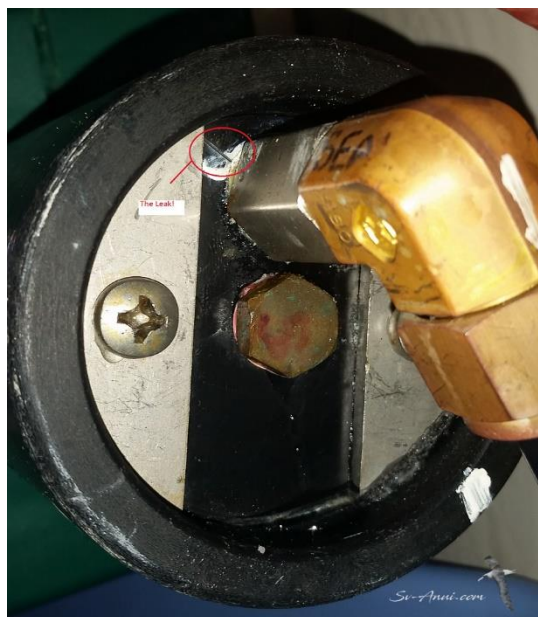
When we first tried to switch it on, we were anchored off Fraser Island. We found pressure was not building, and we could not pump up sea water into the system. We suspected the pump needed priming, probably having air in the pipes. Once primed, the next problem was water squirting everywhere from a crack in the end piece of one of the pressure vessels.

We knew we had a spare on board, so initially thought it was a matter of replacing the end piece, and contacting Open Ocean, the manufacturers based in New Zealand, to order new ones, just in case! However we did not feel we could carry out the work at anchor. We booked into Bundaberg Port Marina, lined up Ray from R&B Marine to oversee the repair. Wade deconstructed the water-maker and tested each part of it in turn, helped by Ray and his off-sider.

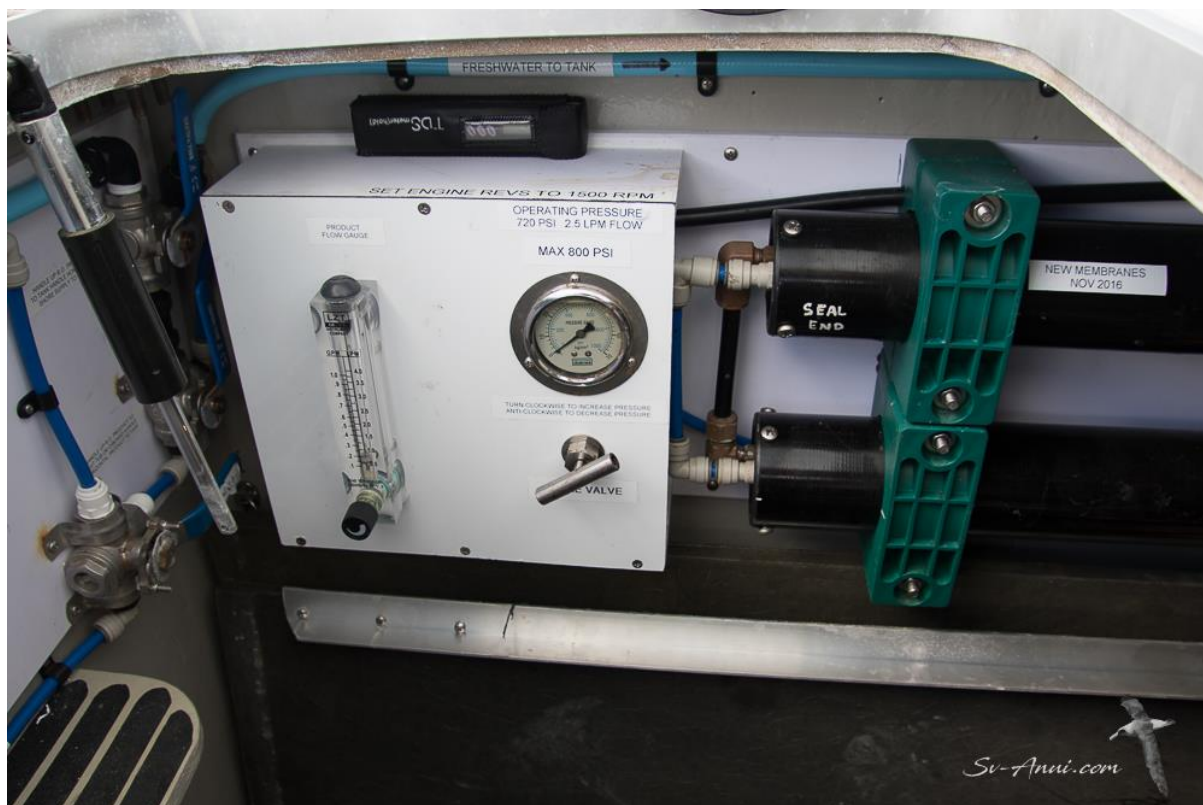
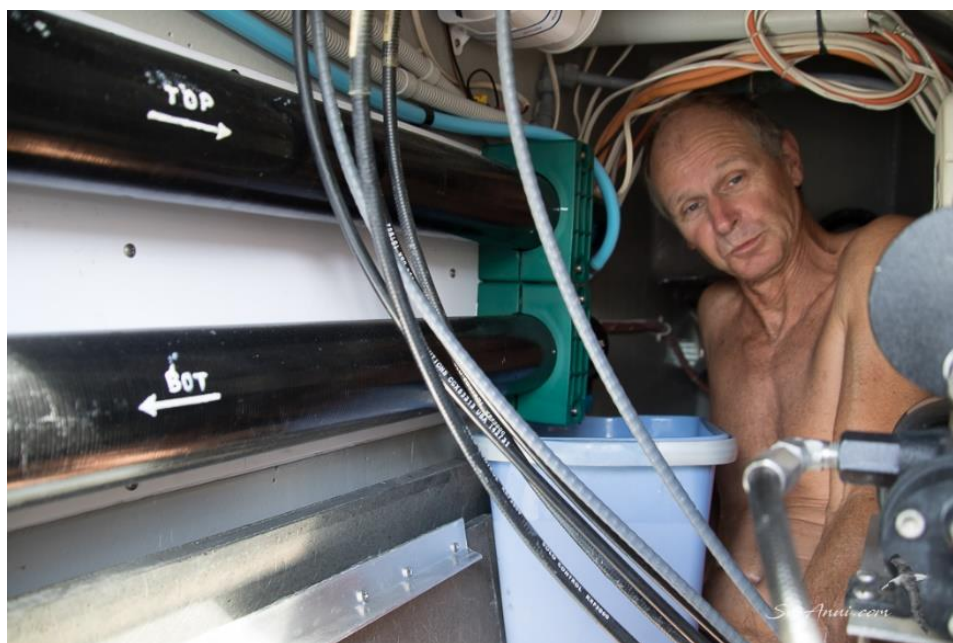
What they found many hours later was that there was not just one problem, the cracked end piece, but four! The lifting pump was dead, the choke was full of gunk from the strong pickling solution, as was the pressure gauge. All these parts had to be replaced. It seems the whole saga was due to using too much meta bi-sulphate in the pickling solution, and leaving it in the pressure vessels for too long. Over time the solution ate away at some of the fittings which perished. A trap for the unwary!

Poor Wade looking a bit dejected, collecting the leaks in a bucket!

We managed to buy the required spare parts in Bundaberg and the water-maker was reconstructed, tested and declared operational on Wednesday 8<sup>th</sup> May, the afternoon of our friend Phil's arrival for his trip on board Anui! The whole repair had taken a week.
