# **Wrestles with Anui**

**The first six months of work**

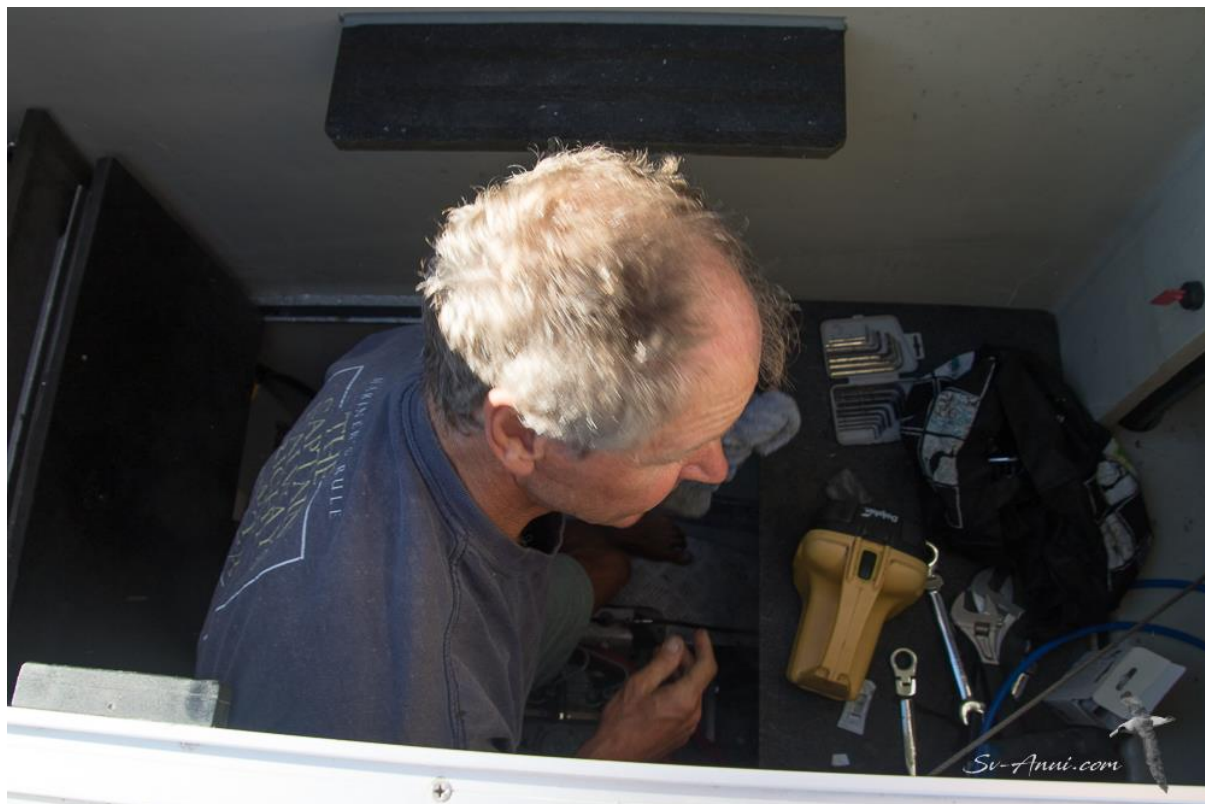
Wade dived into the engine room, but declared it was beyond him. We were incredibly lucky to catch Kent Noble, the local mechanic, very early that morning, before he started working on his 13 other boat jobs. He was quick to diagnose what was wrong: insufficient movement in the gear selection cable, which ended up wearing the teeth on the dog clutch and meant the engine would not go into gear.

Kent was resourceful and fabricated a temporary fix in a few hours, to get us out of trouble. A proper fix requires the boat to be out of the water for about a week... another item for the Boat Works visit at the end of the year!
